Foulants Reduce Effective Heat Transfer – and Cost Money

Our Solution: Ultrasonic Cleaning

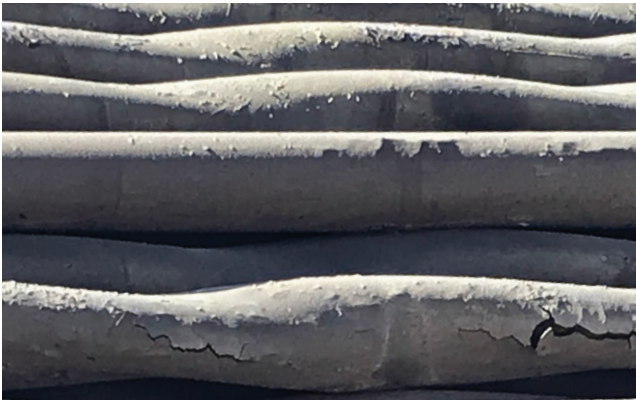
Before

A hydrocracker is a specialized unit in some refineries that takes low-quality, heavy-gas oils and converts them to high-quality, clean-burning fuels through a series of catalytic reactions. Our client was using a set of stainless steel, twisted-type, shell-and-tube heat exchangers in the unit, which they had been unable to clean since their installation 15 years prior. On the tube side, the reactor effluent resulted in a layer of inorganic pyrophoric iron sulfide scale, posing significant danger when exposed to air. On the shell side, the reactor feed resulted in the formation of a polymeric organic olefin fouling, which ranged in consistency from sticky and gummy on the lower temperature units to a hard crystalline foulant on the higher temperature units. Both foulant types are insulating materials, and the inability to clean them was significantly compromising the heat transfer efficiencies on this unit.

For each of the four twisted-type exchangers cleaned during this project, an ultrasonic treatment of 12 hours was applied to the bundles, followed by 10,000 psi hydroblasting for two hours on the tube side and four hours on the shell side. Faster return to service allowed for less downtime and elimination of the bottleneck around this critical path item. But best of all, the bundles were returned to service in a better than 95% clean state, bringing the exchangers back to peak performance and improving heat transfer efficiencies.
